# Geoenvironmental Appraisal

Land at Lower Edge Road, Elland  
For Messrs Stephen & Gary Boyle, and  
Mrs Susan Illingworth

Report no: 4246/1

Date: May 2022

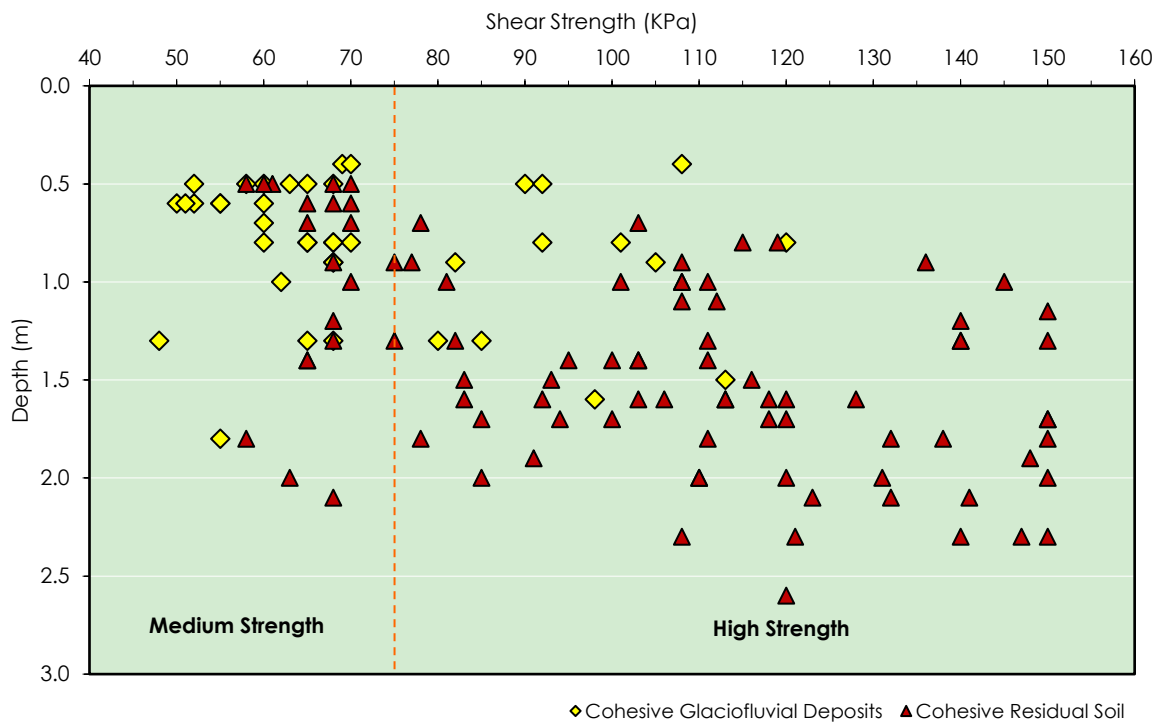
13.5.2 The results are summarised within the plot below and illustrate a broad spread of results in undrained shear strength ( $S_u$ ) with depth within the Cohesive Glaciofluvial deposits (between 48kPa & 119kPa). Below approximately 1.0m depth  $S_u$  is typically greater than 60kPa within the Cohesive Glacial Deposits. Undrained Shear Strength is greater than 58kPa within the Cohesive Residual Soils, typically greater than 75kPa in the majority of tests.

◆ Cohesive Glaciofluvial Deposits ▲ Cohesive Residual Soil
